UNIVERSITY OF ALBERTA

Risk Analysis for Rock Fall on Highways

Christopher M. Bunce

Fall 1994

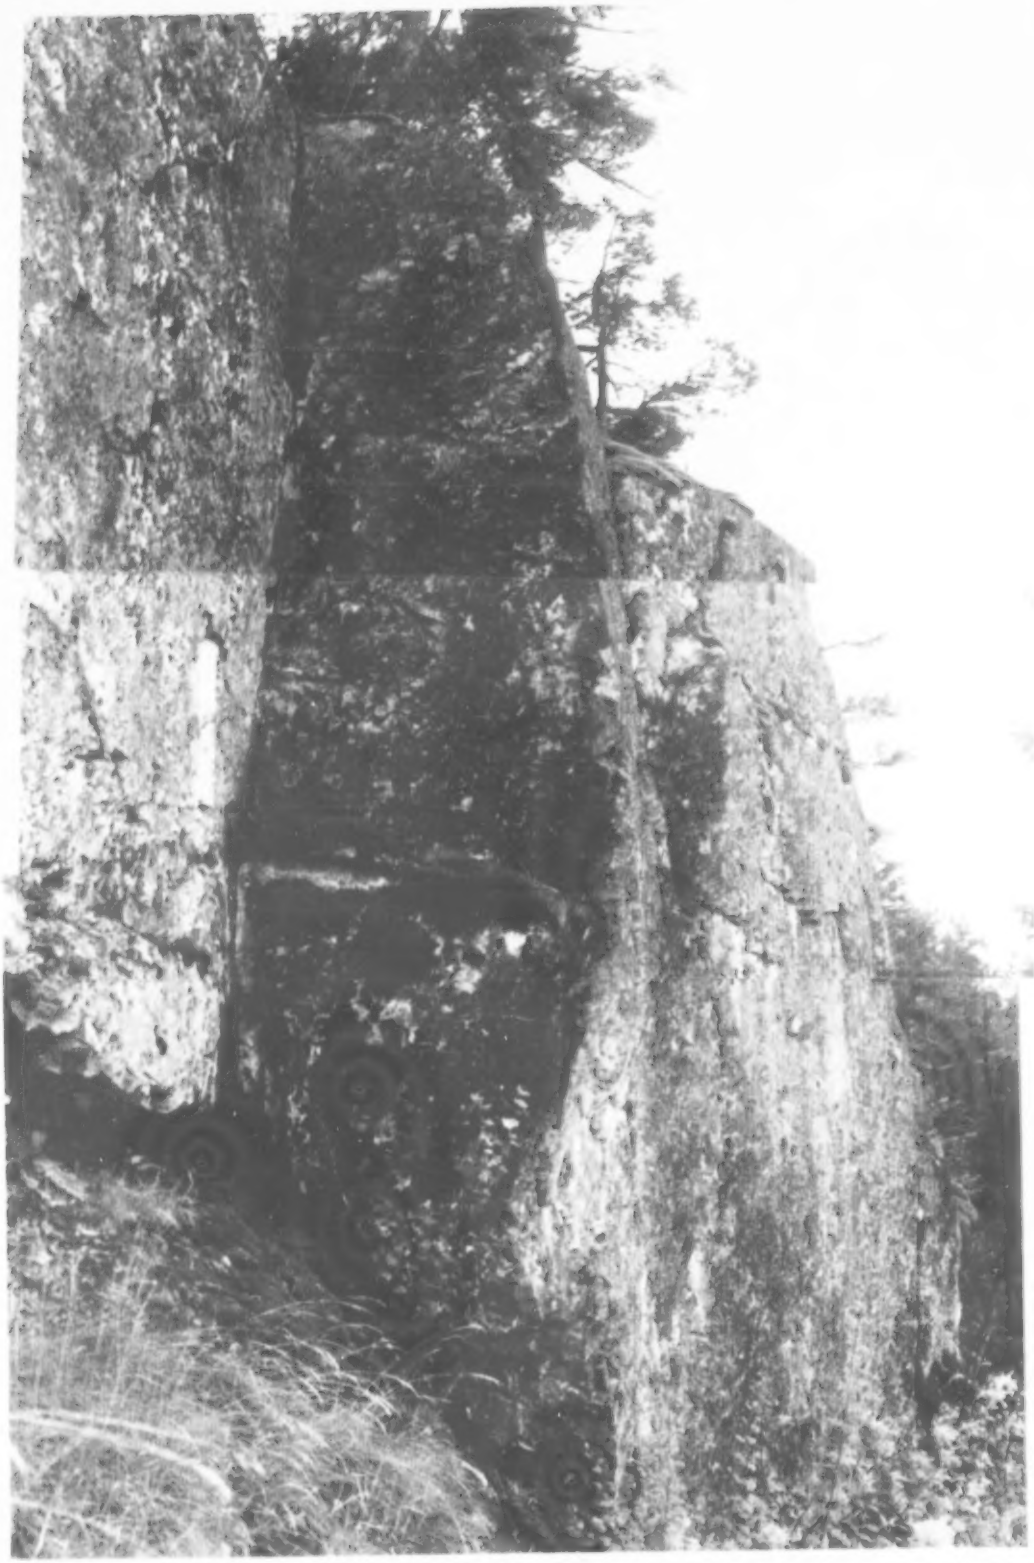
Figure 5.9 Photo of a typical tuff/tuff contact and tree growing above a vertical joint

Figure 5.10 Photo of a portion of the argillite/tuff contact with close jointing at the Argillite Cut

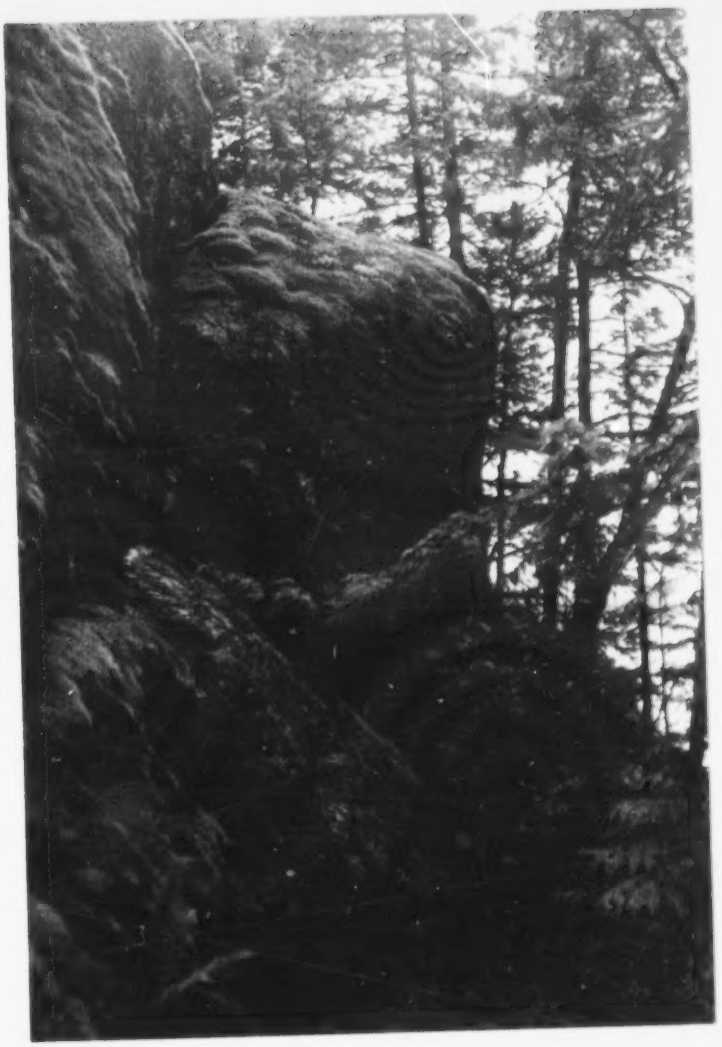
Figure 5.11 Photo of loose block bounded by vertical and daylighted exfoliation joint in tuff above the Argillite Cut

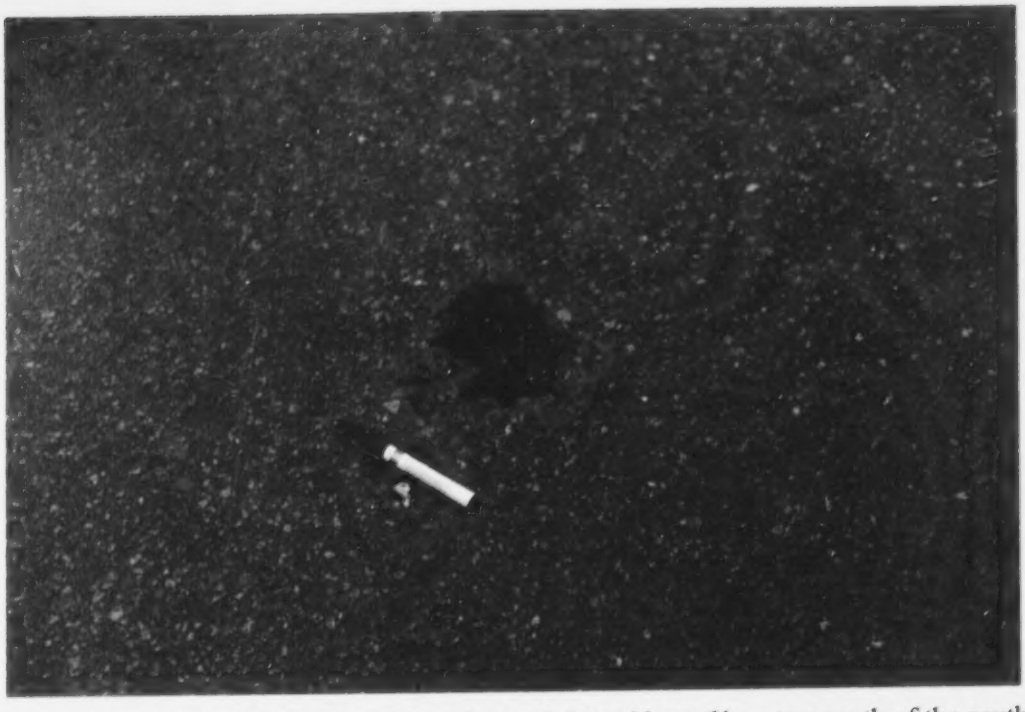
Figure 5.12 Photo of rock fall mark in the south bound lane, 61 metres south of the south bound rock fall sign

Figure 5.13 Photo of rock fall marks and debris on the north bound lane, 45 metres south of south bound rock fall sign

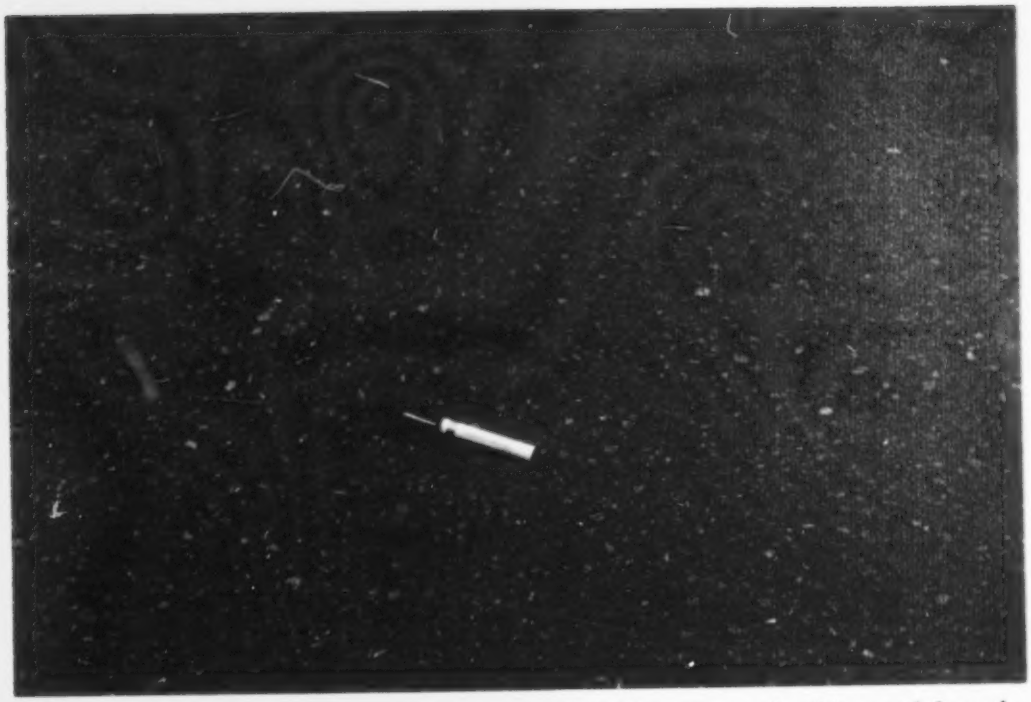
Figure 5.14 Photo of anthropogenic impact mark, 264 metres north of the north bound rock fall sign

Figure 5.15 Photo of northern limit of 1989 asphalt, 41 metres south of the south bound rock fall sign

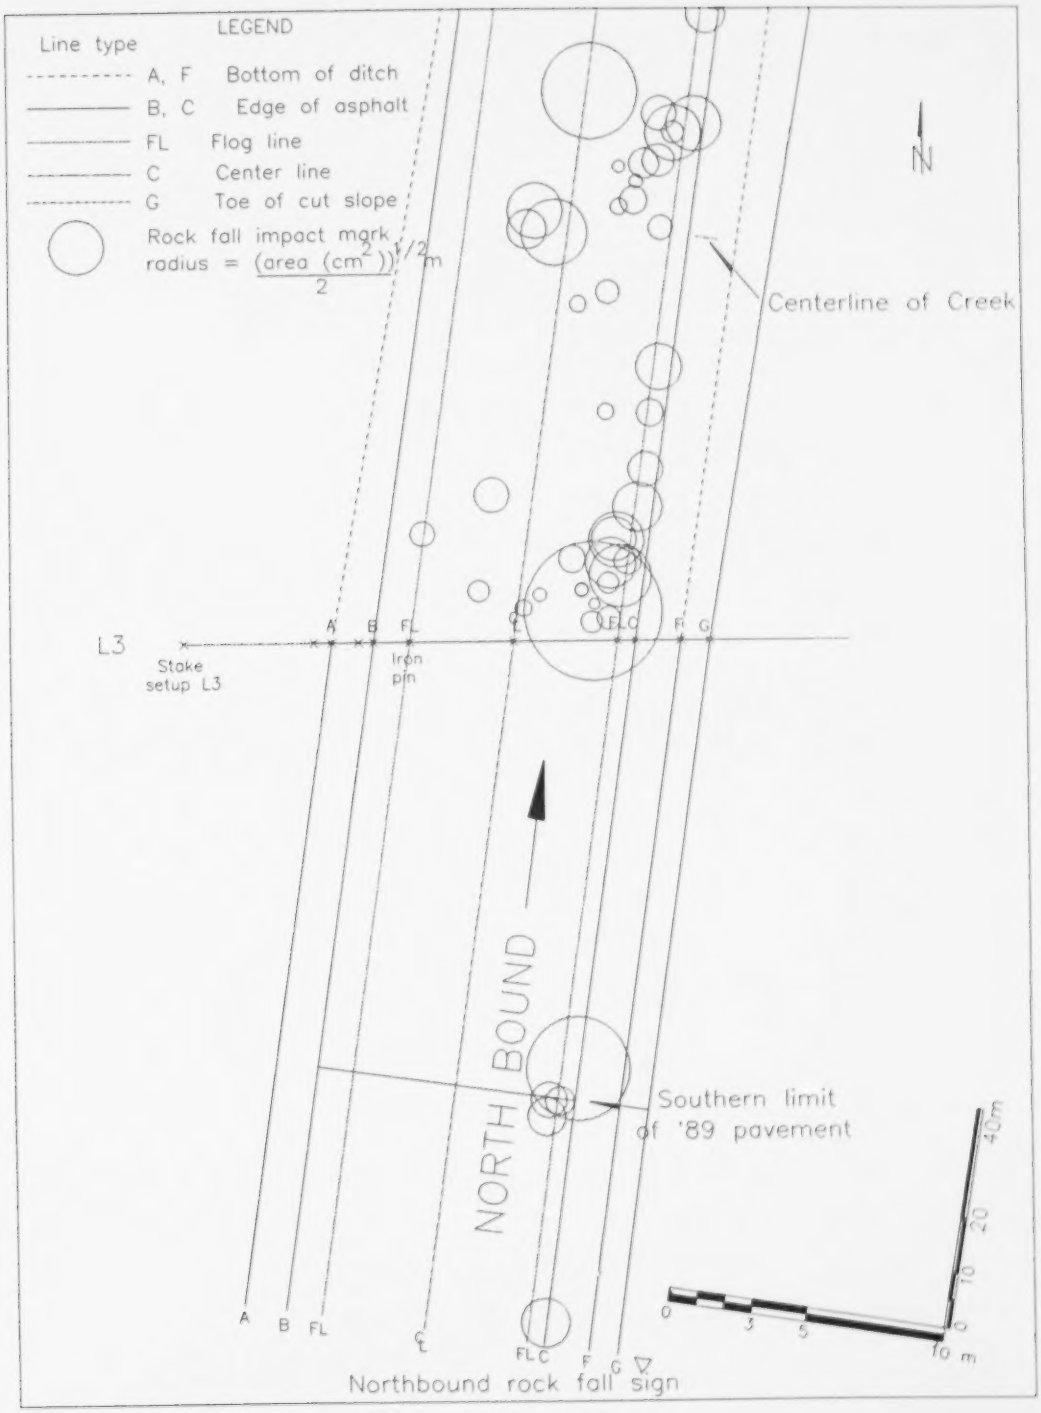
Figure 5.17 Mapping of the rock fall impact marks in the asphalt of the southern half of the Argillite Cut

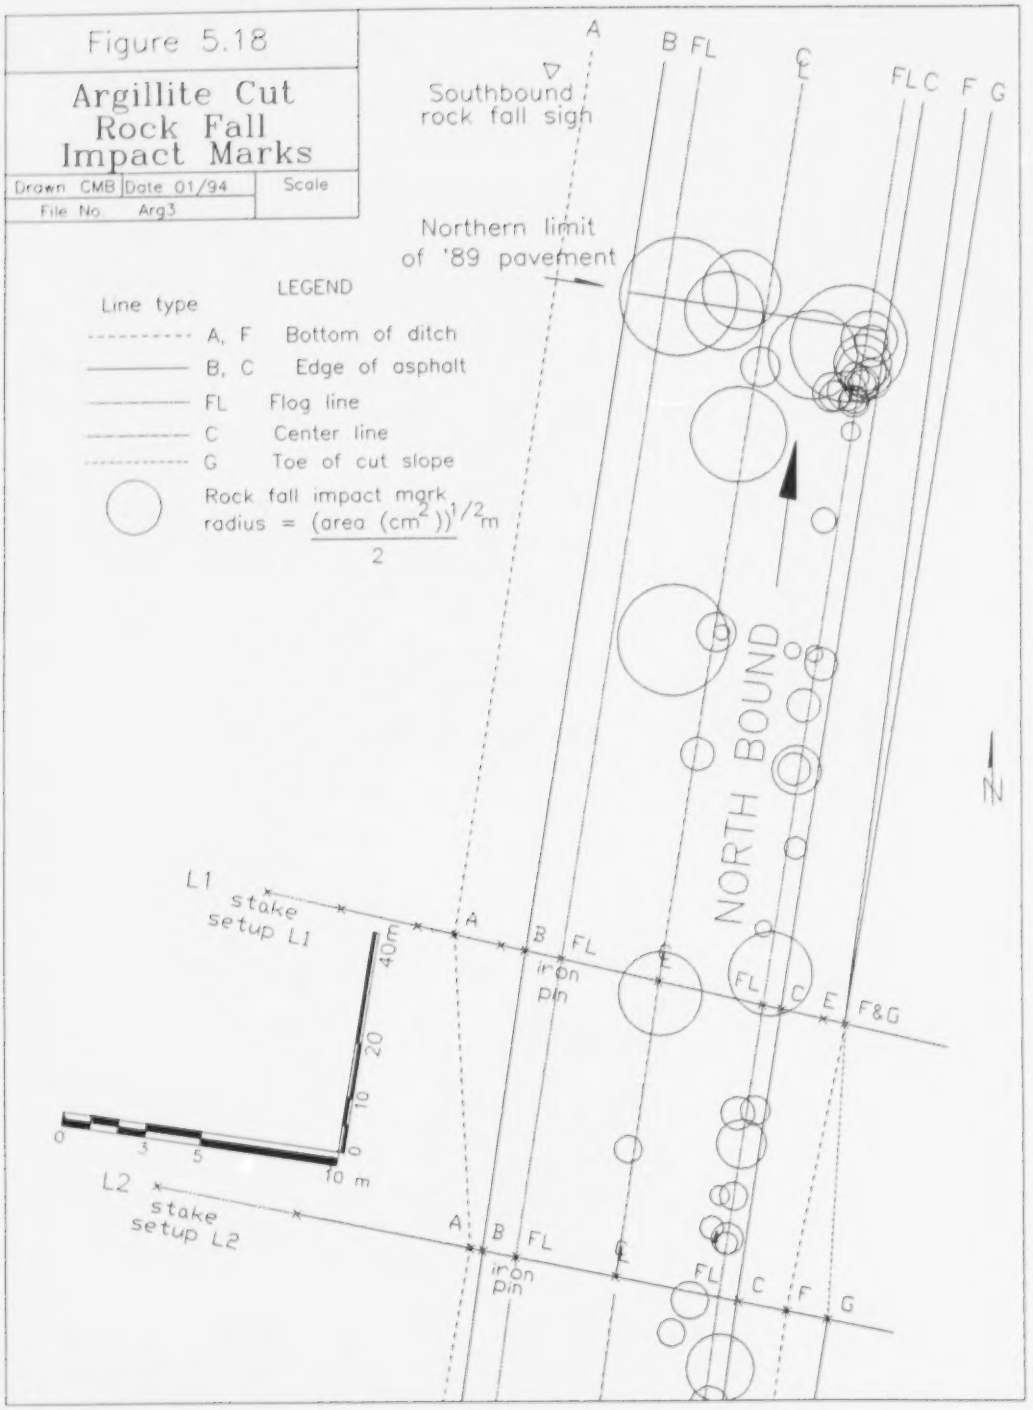
Figure 5.18 Mapping of the rock fall impact marks in the asphalt of the northern half of the Argillite Cut
